SAINT-VINCENT'S CATHEDRAL RESTORATION WORKS

CHALON-SUR-SAÔNE
UNDER THE
MICROSCOPE

Document updated January 2025

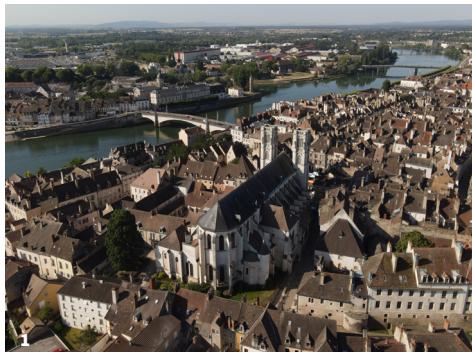
1. Aerial view of the cathedral complex around St-Vincent

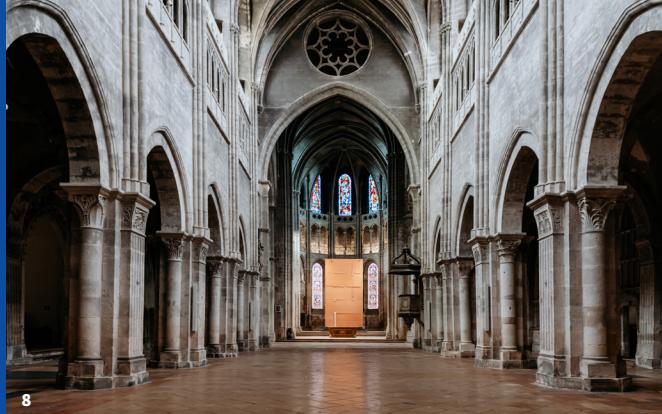
8

8. Interior of the cathedral after the removal of artworks and furnishings. At the back, the high altar under protective casing, 13 March 2024

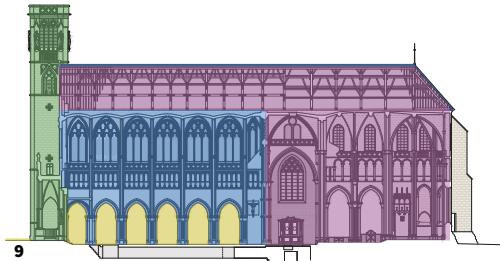
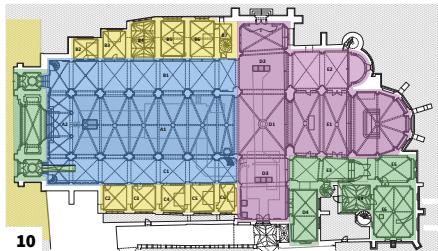
9. et 10. Elevation and plan showing the phasing of the restoration works at Saint-Vincent Cathedral
© 2BDM

Phase 1 : nave, north and south aisles, roofs
 Phase 2 : transept, choir, north aisle of the choir, attics
 Phase 3 : chapter house, sacristy, Jeune Foucaude Chapel, south aisle of the choir, Notre-Dame-de-Pitié, towers and terrace, crypt
 Phase 4 : side chapels off the nave, forecourt

The first phase of works, from March to December 2024, focused on the restoration of the nave, its aisles and the entire roof structure.

In 2025, the worksite moved to the transept and the choir, also including interventions in the roof spaces. Complementary archaeological excavations, following on from those carried out in 2023, were conducted in this area over the same period.

In 2026, the built elements adjacent to the choir will in turn be restored: the north aisle (initially planned for 2025), the sacristy, the chapter house, the chapel called “Jeune Foucaude” Chapel and the Notre-Dame-de-Pitié Chapel. Accessibility works will also be carried out at the opposite end of the building, under the entrance towers.

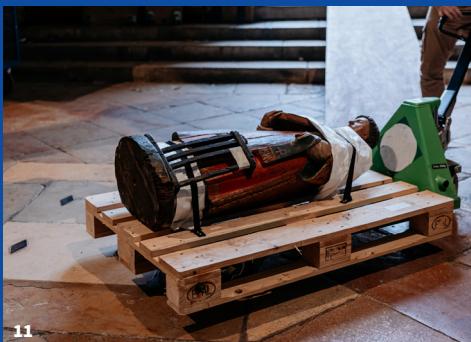
11

11. Polychrome carved wooden statue of Saint Reine being moved to a dedicated storage facility, 6 March 2024
© City of Chalon

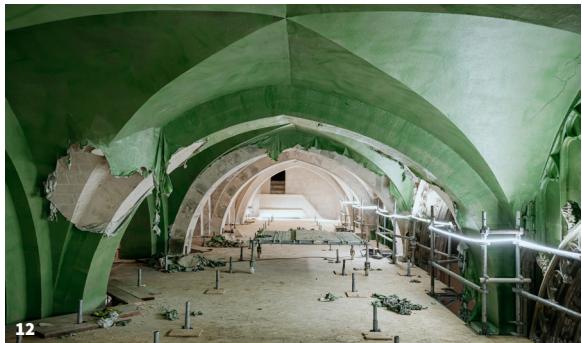
12. Cleaning of the aisle vault with latex,

To clean the heavily soiled stone, Frédéric Didier had in 2006 resorted to what was then an experimental technique: the use of a peelable latex gel, derived from rubber cultivated in Indonesia and Thailand,

harvested and mixed with specific additives. The product is sprayed onto the surfaces, dries for 24 to 72 hours while trapping all impurities, and is then removed by hand as a single film. This technique generates no dust, is harmless both to the historic fabric and to those applying it, and penetrates every surface irregularity. It was this gel that was used to clean the blackened stones of Notre-Dame de Paris after the 2019 fire; it was employed again in 2024 in the nave of St-Vincent's Cathedral.

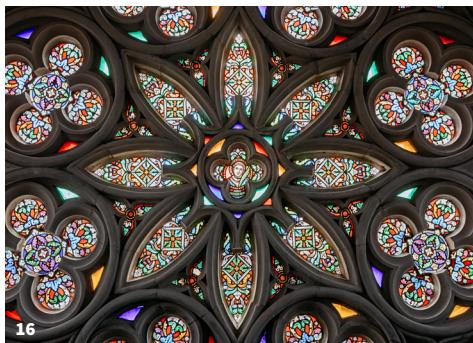
16

16. Rose window in the west façade: Portrait of St Vincent surrounded by arabesques, Émile Thibaud, master glass-painter, c. 1866
© City of Chalon

The rose window has a central medallion showing St-Vincent surrounded by arabesques. The whole is the work of Clermont-Ferrand master glass-painter Émile Thibaud, who played a major role in the mid-19th-century revival of a “neo-archaeological” Gothic-inspired stained glass in France. His work here dates from around 1866. The window

was already extensively restored in 2005, as it had been severely affected by movement in the building caused by unstable ground.

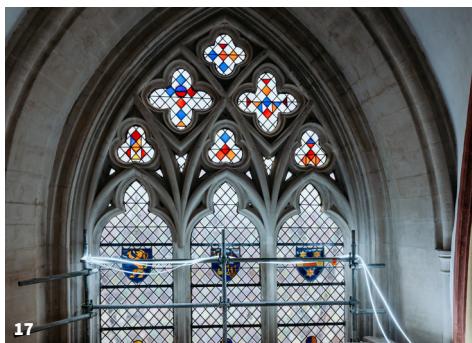
17

17. Stained glass showing the arms of Burgundy and of Bishops Jean Rolin and Jean Germain, Pierre Choutet, master glass-painter, 1945–1951
© City of Chalon

The high windows of the nave are all fitted with stained glass created between 1945 and 1951 by master glass-painter Pierre Choutet, after the destruction of the earlier windows in August 1944. Born in Chalon in 1920, Choutet settled in Paris, where he founded the Société des Vitrails d'Art des Gobelins, responsible for numerous contemporary stained-glass creations in post-war France.

Here, the commission was to depict, at the centre of each window, the coats of arms of the bishops of Chalon from the 12th century

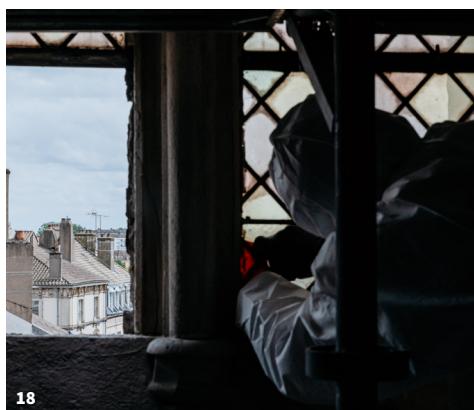
18

18. Removal of the lower stained-glass panels in the nave, June 2024
© City of Chalon

In order to cut back the stained glass at the lower sections of the nave windows and thus improve the cathedral's future ventilation, it was necessary to remove the lower panels of each nave window in summer 2024. To avoid leaving the building open to the elements during this phase, custom-cut plexiglass sheets were installed in their place.

Once removed, the lower panels of the nave windows were carefully transported by the Art Vitrail team to their workshop near Auxerre. There, a detailed condition report was drawn up: broken pieces were recorded and marked with stickers for identification,

and photographs were taken before restoration. The metal saddle bars and perimeter lead cames were removed so that the broken glass pieces could be replaced. Once the new glasses had been cut and fitted, they were reinserted into the mullions. New border cames were then installed all around, and the whole soldered.

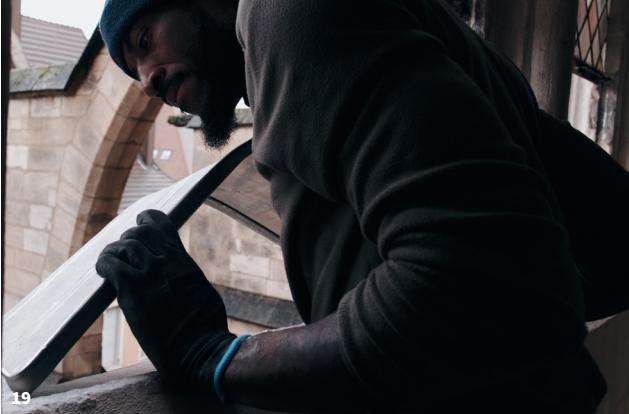
19. Installation of a lead drip tray, September 2024
© City of Chalon

To remove condensation water running down the interior face of the windows—water that could stain the newly cleaned walls—lead drip trays were made in situ. Their role is to collect this water and channel it outside the building. Installing these elements required slightly trimming the stained-glass panels.

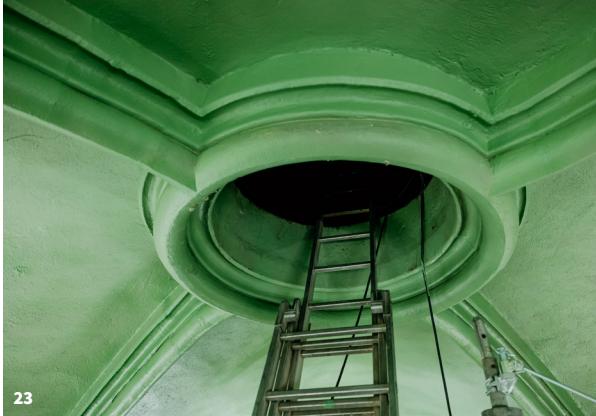
23

23. Latex cleaning of the oculus at the crossing of the transept, December 2024,

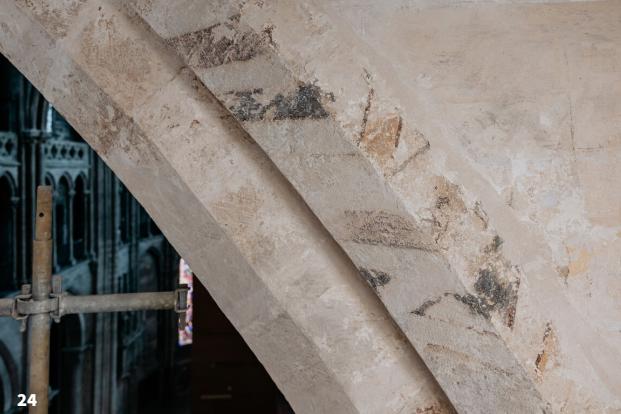
24

24. Discovery of polychrome chevrons on the pointed arch between transept and nave, 2024
© City of Chalon

Colour traces were also found on the pointed arch between the nave and transept, decorated with highly coloured chevron motifs. These features were analysed and similarly brought back to life.
